Rehabilitation and completion works at Bumbuna Falls HEP: a case history of interrupted and continued implementation activities

Bela Petry
Consultant
Kolk 1
2611 KC Delft, Netherlands

Alberto Bezzi
Studio ing.G.Pietrangeli
via cicerone 28
00193 Roma, Italy

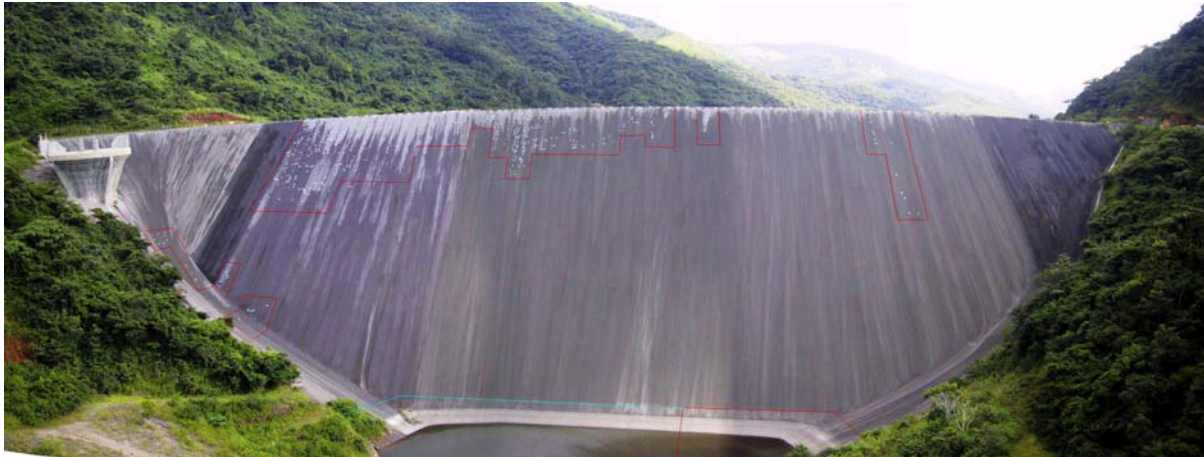
Visual inspection showed the occurrence of fissures, cracks and ripples in extensive areas of the upstream face corresponding to about 35 % of the total surface.

- Cracks – Large and deep cracks crossing the entire impervious layer, or penetrate deeper than half of the layer thickness were detected over an area of about 1000 m². Repair works were considered necessary to restore the functionality of the lining in these areas
- Fissures - Fissures penetrating less than 2 cm into the layer were detected over an area of about 15000 m². Repair works were also deemed necessary to assure the long term performance of the lining in these areas
- Superficial Fissures – Patterns of surface fissures were present over almost the entire dam facing. In these areas the treatment could be restricted to the application of the sealing coat.

Figure 3-Impervious facing at the end of the interruption period

On the basis of results of the site inspections and the laboratory tests, the following causes for the impervious membrane quality decay were identified:

- ageing phenomena of surface-level bitumen (oxidation, hardening, loss of adhesion) due to long term exposure to air and sunshine without a sealing coat protection,
- high temperatures reached by the lining due to direct exposure to sun radiation without the mitigation effect of an impoundment.

It is also likely that, in the areas where major fissures were observed, the quality of the impervious layer was inferior to that of other parts of the lining due to different placing and compaction conditions or other reasons related to the mix characteristics (performance of anti-stripping agent, filler-bitumen ratio, etc) causing the acceleration of the ageing phenomena and the occurrence of deeper fissures.

- Milling the face surface to a depth of 3 cm, except in the zones where the upper layer had not been completed before interruption. The minimum thickness of 3 cm was considered a suitable average value based on samples cored in the areas where the effects of the ageing phenomena were more noticeable.

- Placing of a 6 cm thick impervious layer over the entire face area and protection by a seal coating to prevent against ageing effects

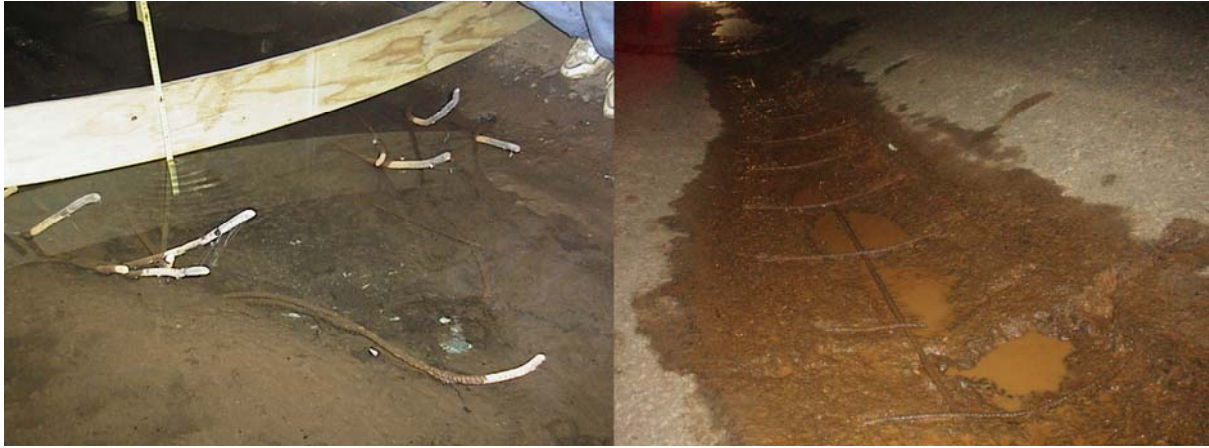
The extended use of the right and left tunnels for diversion purpose (1992 – 2004) has resulted in similar erosion phenomena in the concrete lining of both tunnels. The main types of erosion occurrences observed during site inspections can be classified as follows:

- Deep erosion - The occurrence of intense erosion effects in the invert zone was observed in both tunnels. Affected areas, extending over the entire tunnel length and a 2 to 4 m wide strip in the invert zone, are indicative of erosion mainly caused by sediments transported by the flow during the diversion period. The maximum erosion depths observed in different sections ranged from 2 to 12 cm. In some locations, steel meshes and reinforcement bars were exposed and damaged. The occurrence of deep holes with depth ranging from 10 to 25 cm was observed near the steel lined sections and in locations where steel reinforcements were destroyed.

Figure 4-Erosion along tunnels invert zones

- Superficial erosion - Areas characterized by shallow erosion occurrences had not been subjected to any perceivable geometric change but, due to the uncovering of aggregates, presented an increased roughness ranging from 2-3 mm to 7-8 mm. Furthermore, leakage paths were detected in several zones, especially in the areas corresponding to the construction joints.

- Minimum 5 cm deep cut- out and removal of the concrete by scarification down to 2 cm below the pre-existing reinforcements.
- Cleaning of base surfaces requiring an overlay by high pressure water jets to enhance bonding
- Brushing of reinforcements to eliminate adhered concrete, rust and oxidations.
- Where the existing reinforcements were eradicated, the bars have been replaced
- Use of a mix consisting of sand, cement and synthetic resin emulsion as bonding agent

- Control of potential shrinkages by use of very low w/c ratio repair concrete. Use of welded wire mesh in order to reduce shrinkage potential

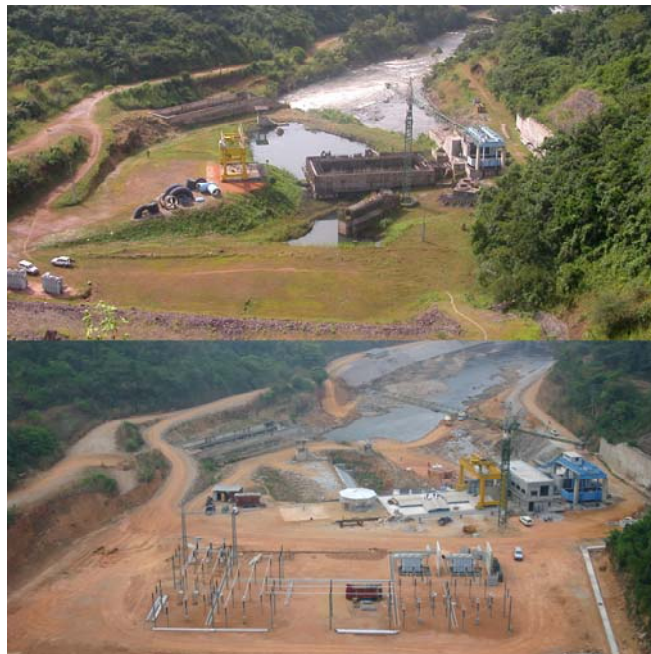
Figure 5-Rehabilitation and completion works in the Powerhouse and Substation area

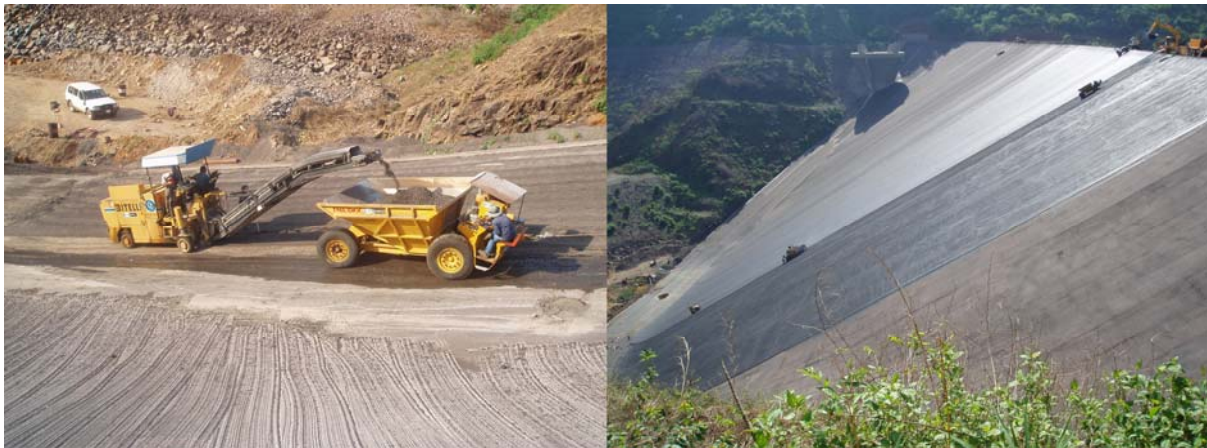
Figure 6–Rehabilitation works of the asphalt concrete facing

The impervious facing was completely rehabilitated by a sequence of operations that included:

- Rehabilitation works along the cut-off wall by replacing damaged copper foils and removal of vegetation (e.g. roots).
- Cleaning of the entire milled surface from debris, oil patches; drying and application of an emulsion (tack coat) by spraying, in order to ensure an effective bond between the old and the new impervious layer.

- Execution of a 300 m² area trial facing and testing
- Placement of the impervious lining in the areas that had not been executed before the interruption of works.

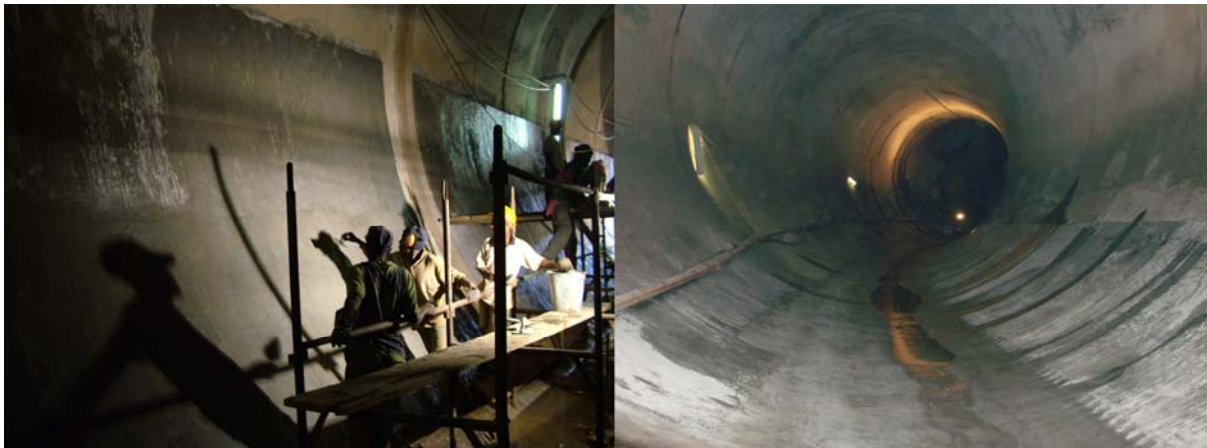
Figure 7-Tunnel rehabilitation works

Deep erosion (surfaces with irregularities greater than 4 cm) – deep erosion occurred mainly in the invert zones. The following technical guidelines were adopted for the treatment of such occurrences:

Superficial erosion (surfaces with irregularities between 5 mm and 4 cm) – surface erosion occurred mainly along the sidewalls. Repairs were carried out based on:

- Cleaning of eroded surfaces using water jets at operating pressures of 200 bars, in order to remove eventual loose material and eliminate oil and grease as well as organic and inorganic deposits.
- Wetting the cleaned surfaces up to complete saturation, one day prior to mortar application; removal of excess water by compressed air jet a few hours before the application
- Use of a pre-packaged fibre reinforced and shrinkage free mortar, applied to the prepared surface by a flat trowel. The high strength (40 MPa) characteristics of the mortar, along with the proper preparation of the surface were considered necessary to secure the required bonding and resistance of repaired parts.

Finishing- all surfaces repaired using the procedure described above were finished using a pre-packaged two-components cement mortar; application using a flat trowel to a maximum thickness of 3-4 mm

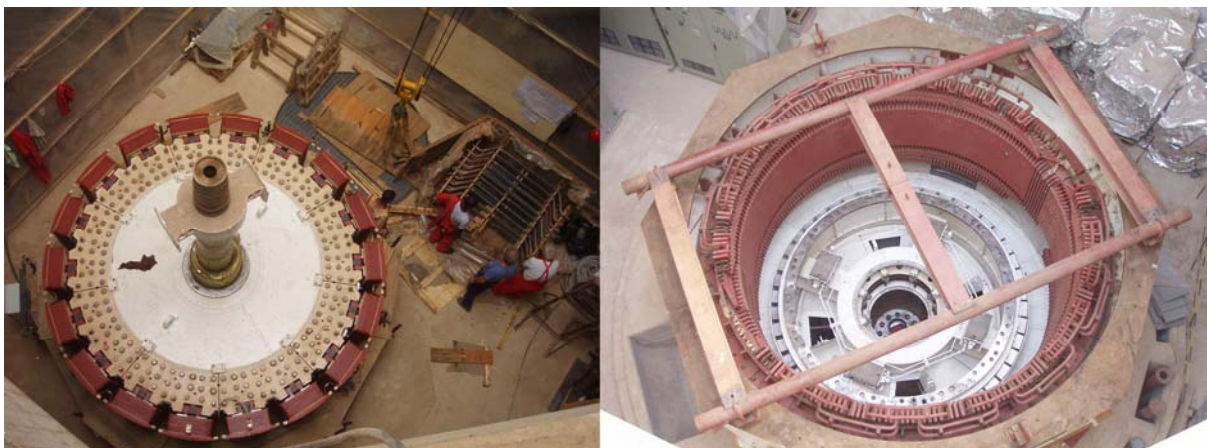
- Stator halves- moisture and contaminants were removed by cleaning and heating. Refurbishment of a number of coils was carried out by the generator Manufacturer.

- Rotor poles- several rotor poles have been found badly rusted and displayed a very low insulation capacity; 8 poles were sent to the manufacturer’s workshop for rehabilitation while the remaining ones have been properly maintained at site using heating. The tests performed after the erection of the Unit 1 rotor were found to be satisfactory

Figure 8-Assembly of generator rotor and stator after rehabilitation
